# Saltmarsh *Paintings Conservation*

**Conservation treatment report for  
*The Royal Coat of Arms to George III***

<b>Report no.:</b>	<b>SAG/01/2023</b>
<b>Date:</b>	29 <sup>th</sup> November 2023
<b>Author:</b>	Polly Saltmarsh Saltmarsh Paintings Conservation Cambridge
<b>Photographs:</b>	Polly Saltmarsh, 2023

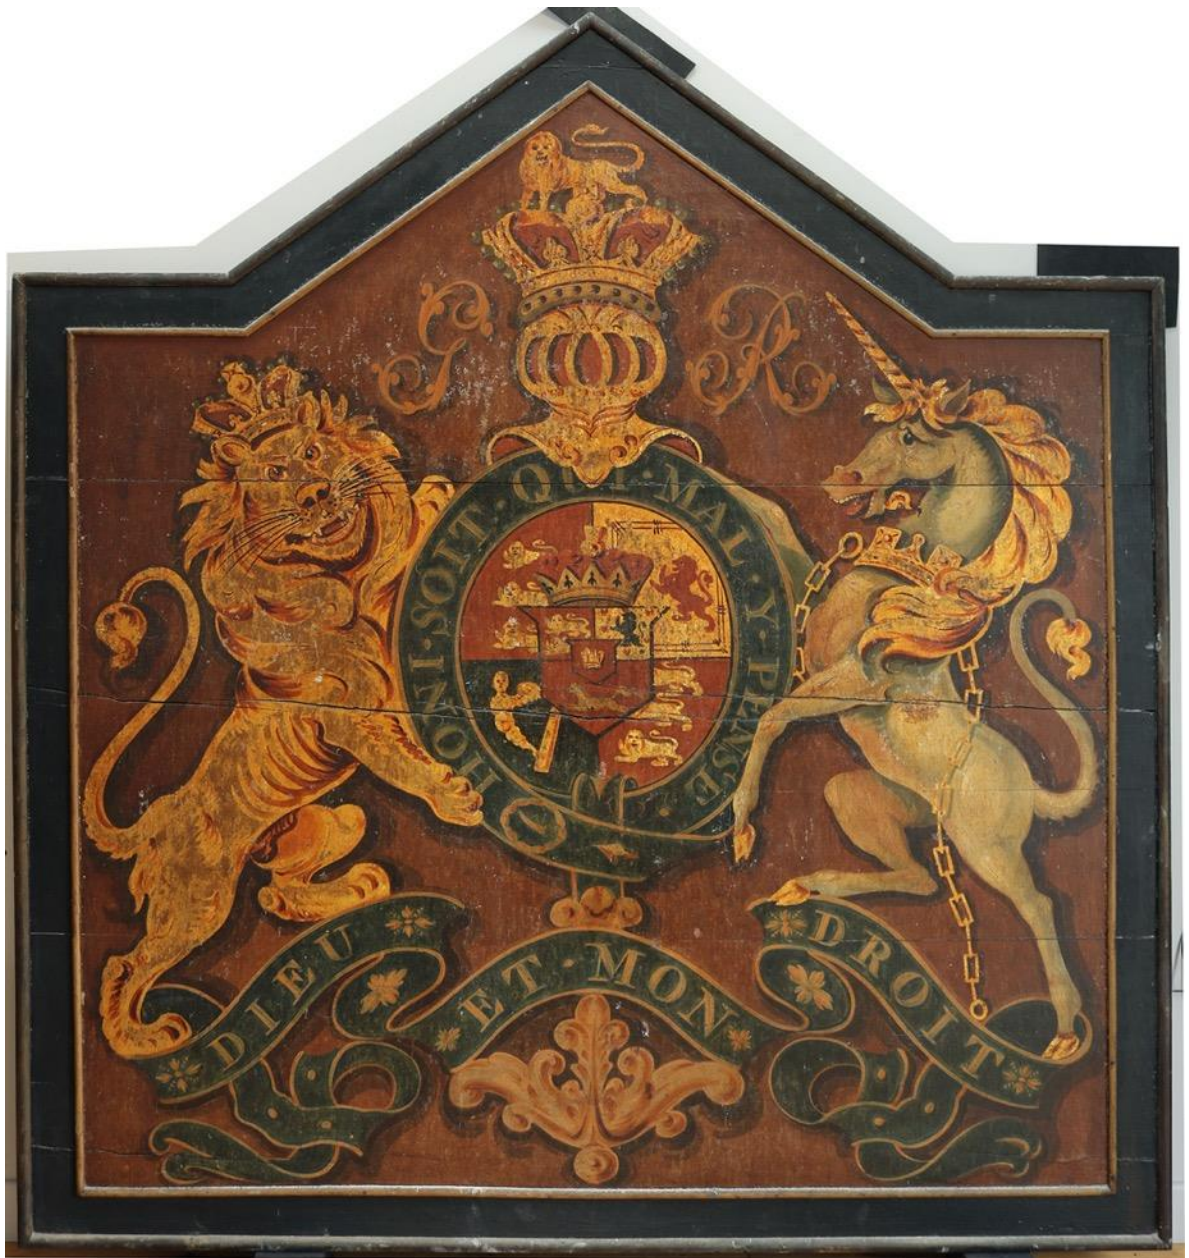
Plate 1 *Royal Coat of Arms, before treatment*

The paint layers are in a good condition. There are localised areas of cracking with some raised edges. Areas of gilding appear worn, possibly through over cleaning in the past. The red background has extensive staining which is likely to be due to a combination of moisture and bat urine, causing a mottled visual effect which is disturbing to the viewer. The aged varnish is affecting the tonal balance and original colours of the composition which are dull. In areas the degraded varnish had flaked away and whiteish haze had formed on the surface. In raking light, changes in the composition are evident, such as a circular motif in the lower half. This may indicate that the design of the Arms was adapted and changed during the painting process but there was no evidence of an earlier Coat of Arms.

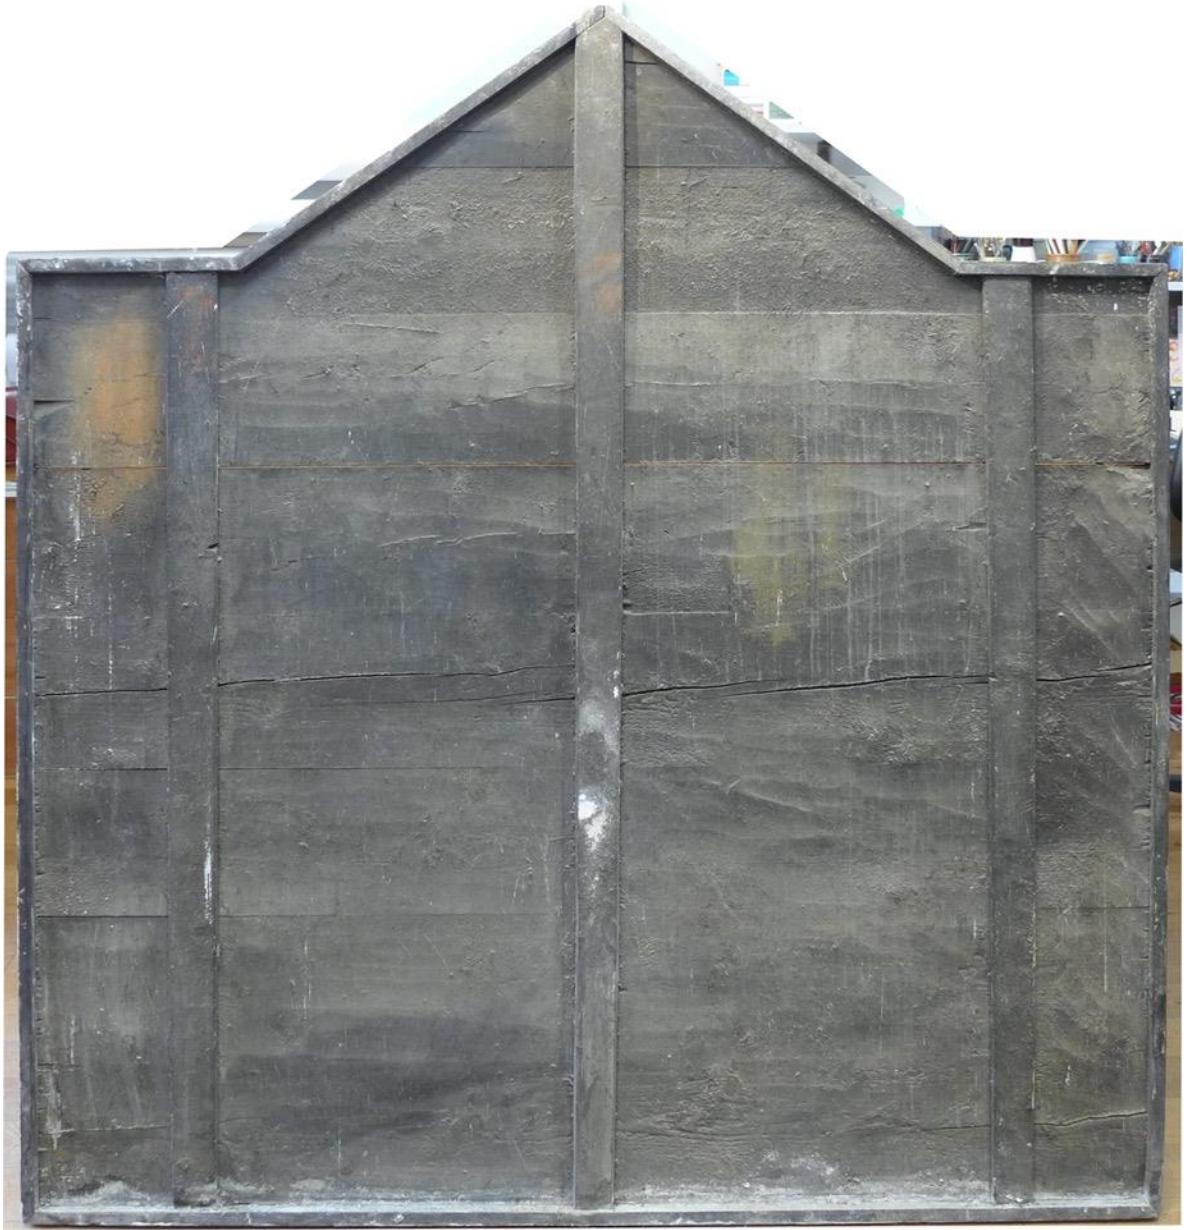
**Plate 2**      *Royal Coat of Arms*, before treatment, reverse

The painting is executed in oil on a wooden panel measuring 184 x 171 cm at its maximum dimensions. The panel is formed from four boards in a horizontal alignment. The four boards also make up the frame of the picture and decorative moulding has been attached to the front surface to indicate the main panel and the frame. The boards are unusually wide, almost 45 cm, and are likely to be English oak. The original tool marks are visible on the reverse of the panel. The boards are held together with vertical battens which were nailed onto the reverse prior to the painting being executed, the shape of the nail heads are evident in some areas below the surface of the paint. The central board has developed a split, following the grain of the wood. This has happened at an early stage in the paintings history; there appears to be no recent movement in the wood and the panel appears to have acclimatised to the environment. Overall, the panel is in a good, stable condition with no evidence of woodworm damage or rot.

The reverse of the panel was cleaned with a stiff brush and vacuum to remove a thick build-up of dust and dirt. The black painted element forming the frame was cleaned with a dilute solution of ammonia to remove ingrained dirt and grime. The top edge of the frame had a thick layer of dirt. This was softened using a poultice of Laponite, 7% in deionised water, before carefully scraping off the dirt with a scalpel. The final layer in contact with the paint layer below was cleared with ammonia solution on a cotton swab.

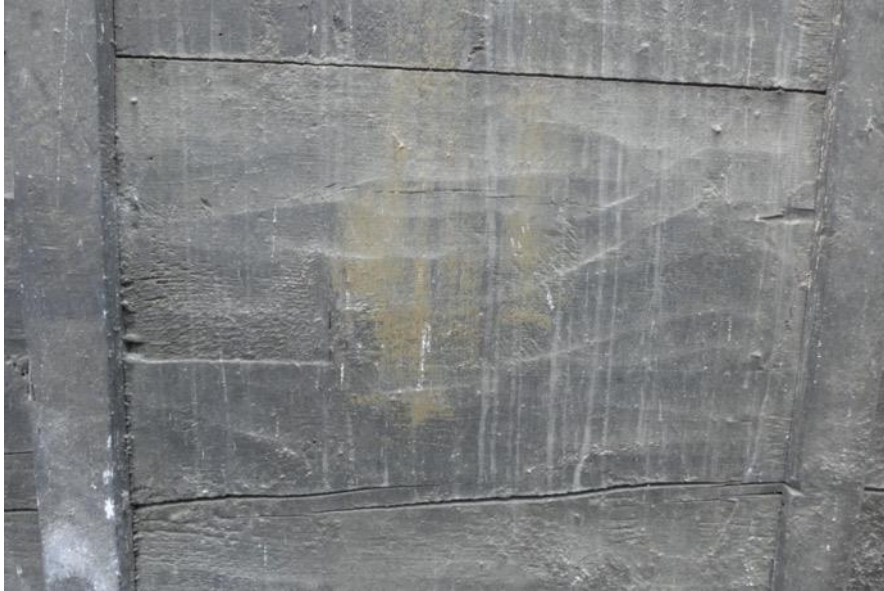
**Plate 3** Detail of original tool marks on the reverse of the panel

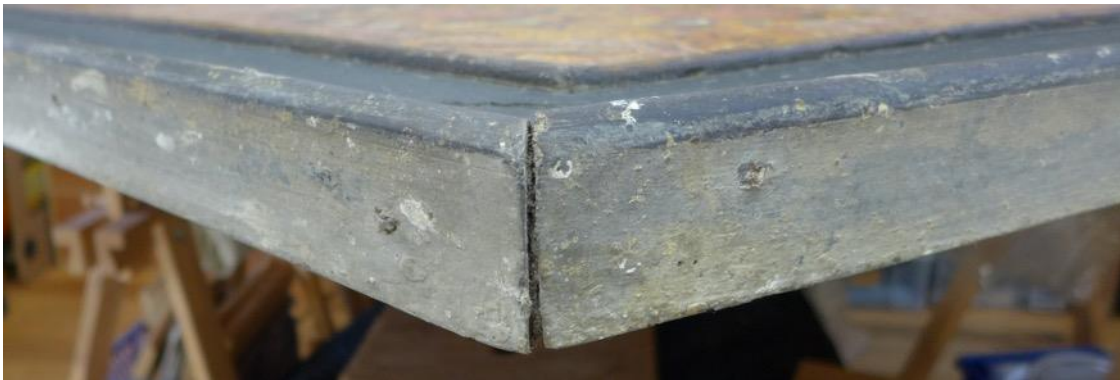
**Plate 4** Detail of thick build up of dirt on the top of the frame

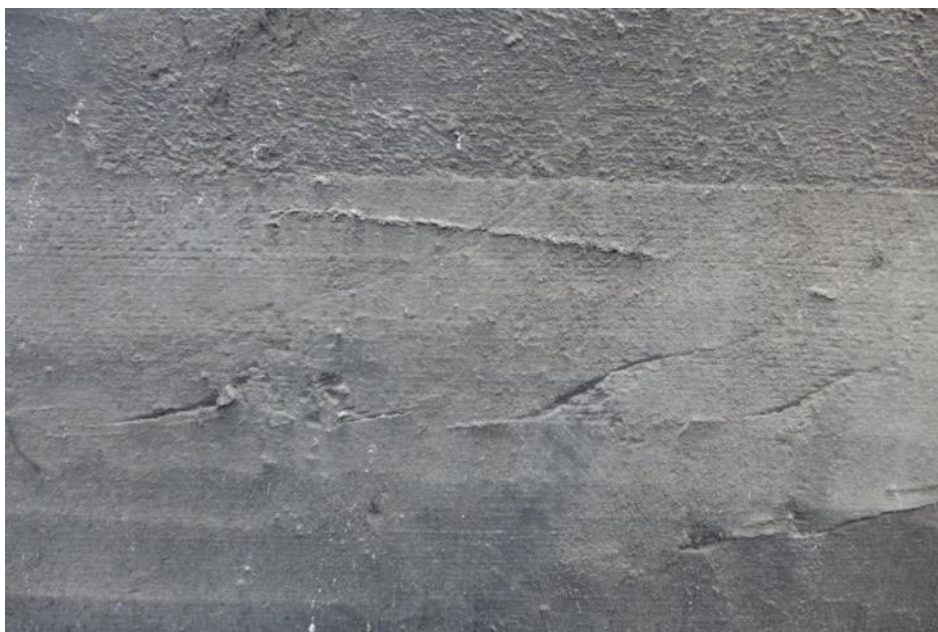
**Plate 5** Detail of thick build up of dirt on the reverse of the panel

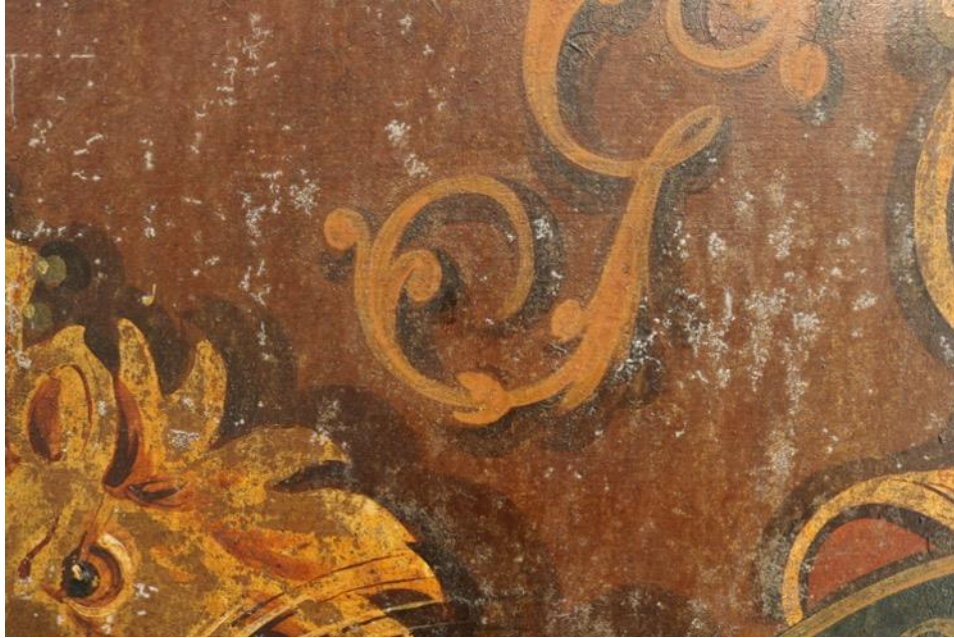
**Plate 6** Detail of white haze and mould on the surface of the varnish

Tests were undertaken to find a safe solvent solution with which to remove the varnish layer. The varnish is probably formed from several layers and was found to be tenacious. Free solvent mixtures did little to solubilise the degraded varnish. A gelled solution of acetone solvent, applied to the surface and left to work for one minute softened the varnish which could then be cleared with acetone. Once the upper layers of varnish were removed, a broken up surface coating was found which remains on the surface. This was found to be insoluble in all solvent and aqueous solutions. It was decided to leave this coating rather than pushing the cleaning further. The gilded areas of the painting were found to be very sensitive to solvent action and in these areas the upper varnish layers were thinned.

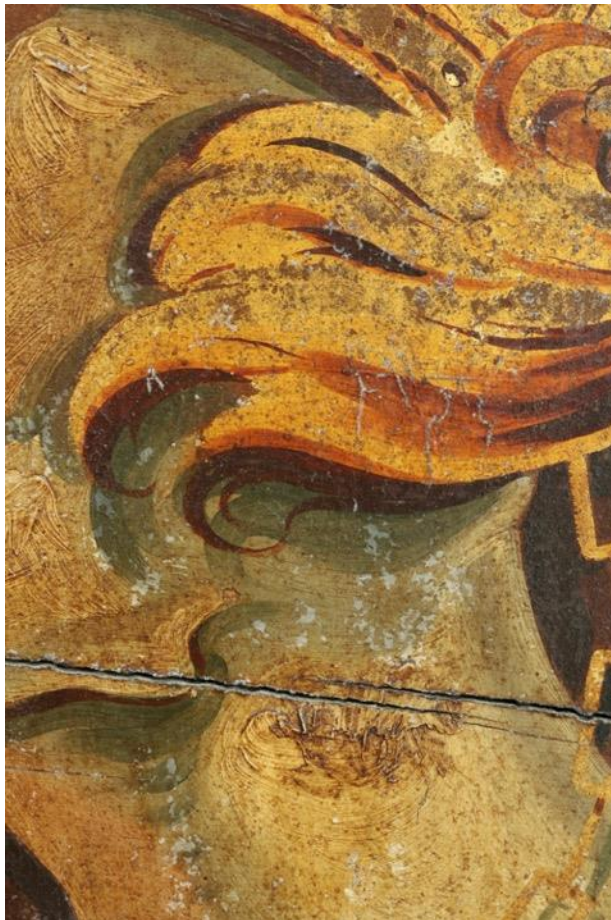
**Plate 7** Detail of losses to the varnish and staining underneath the varnish

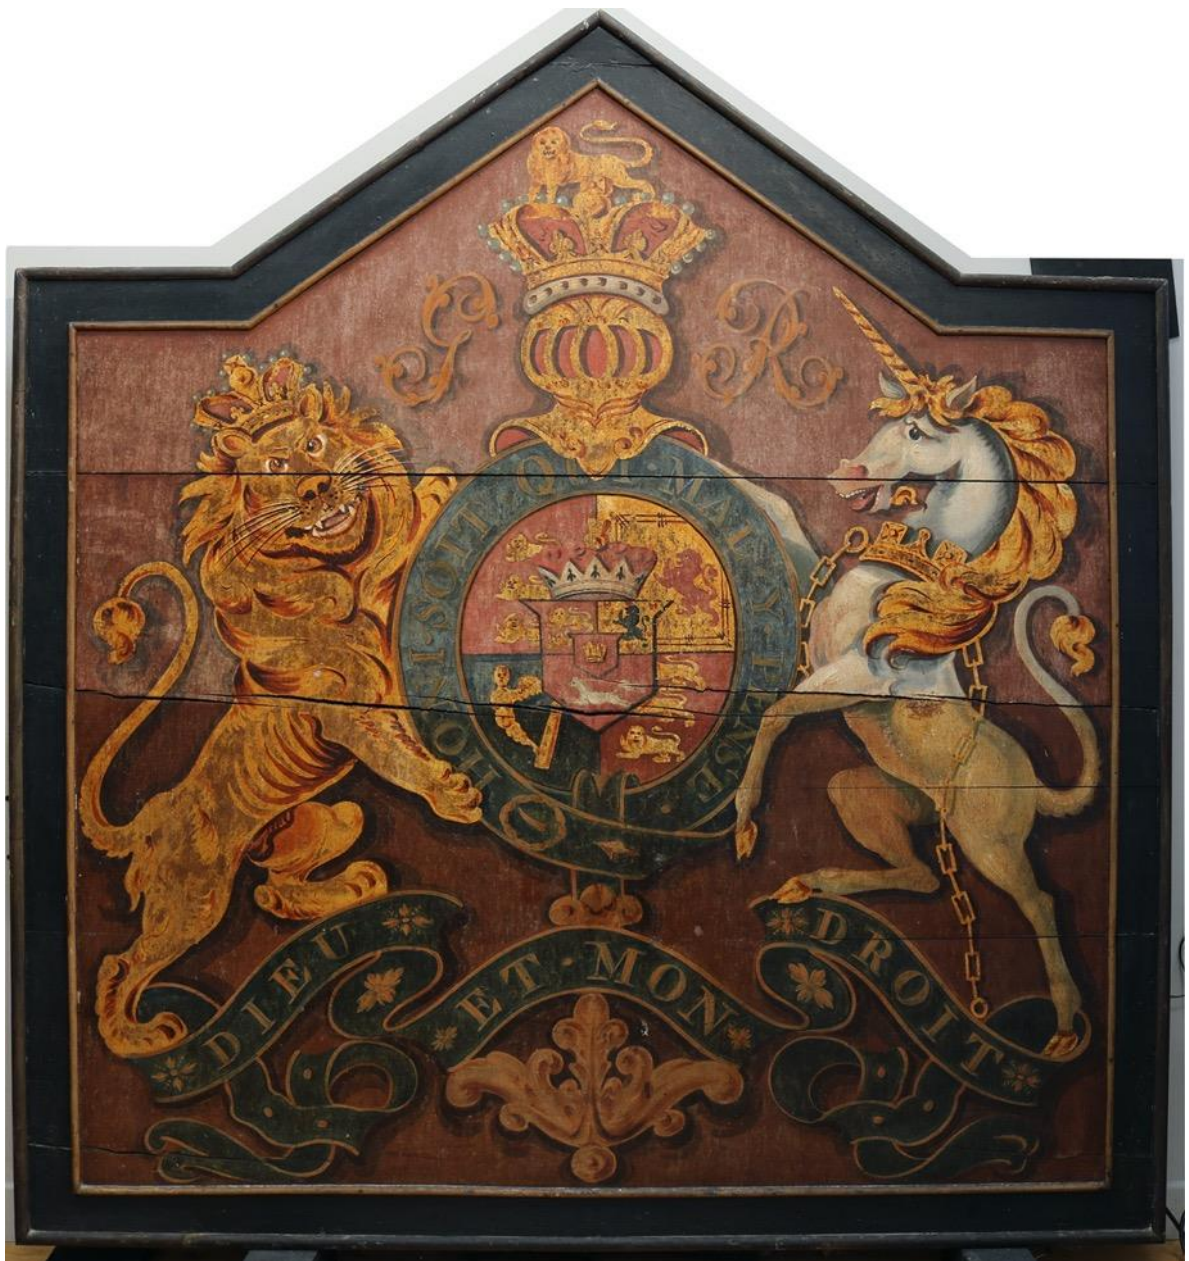
**Plate 9** During varnish removal

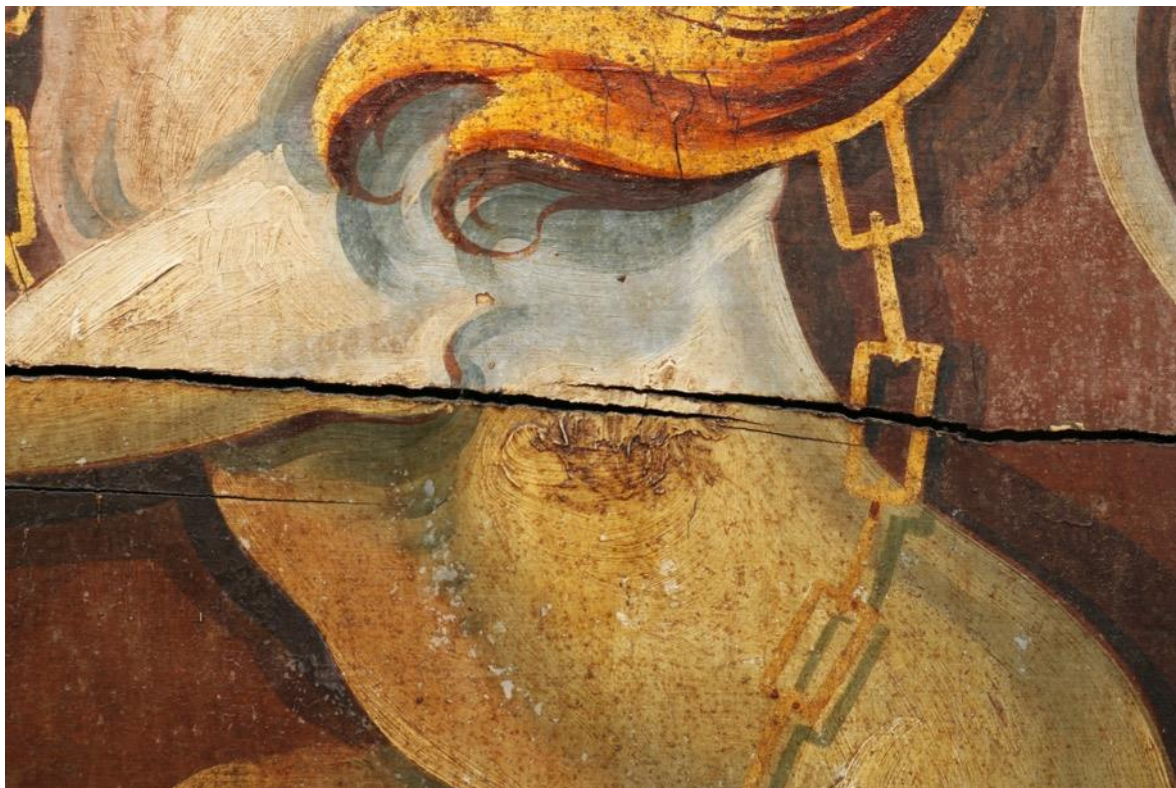
**Plate 10** Detail during varnish removal showing how yellowed the old varnish layers had become

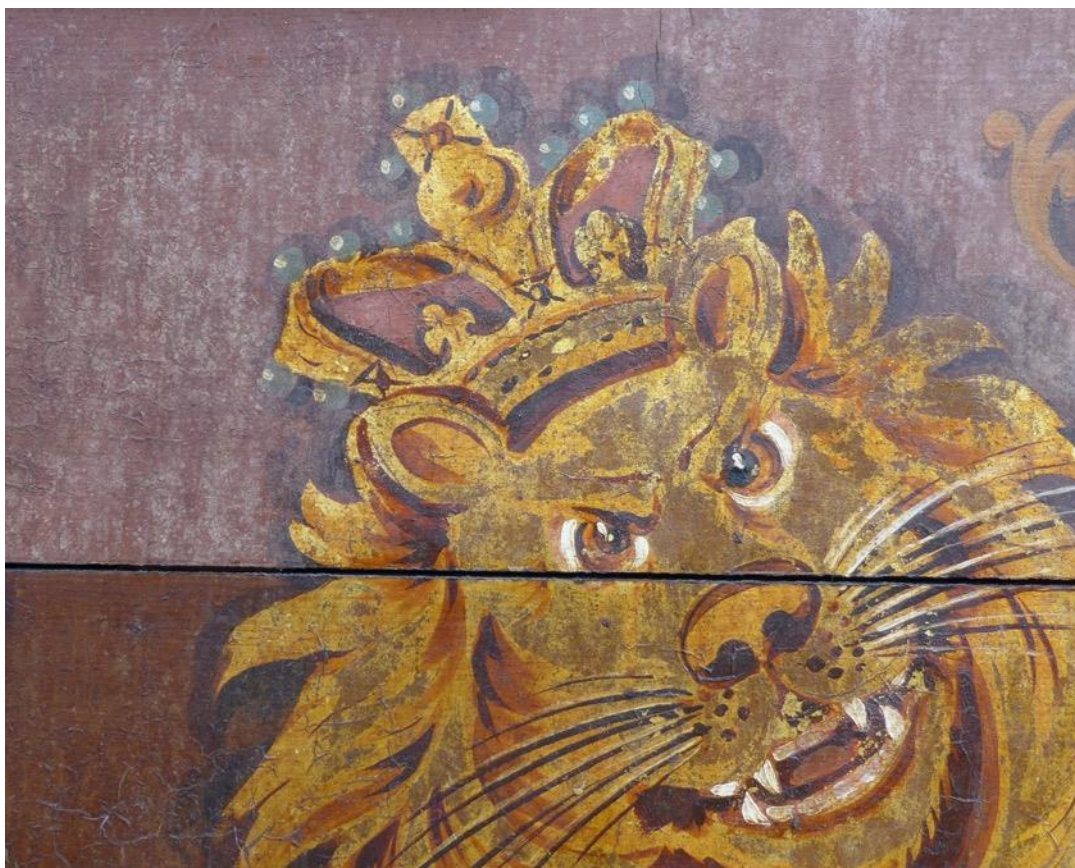
**Plate 11** Detail during varnish removal. The clean area at the top has lost saturation and the staining and degraded coating the background is more apparent

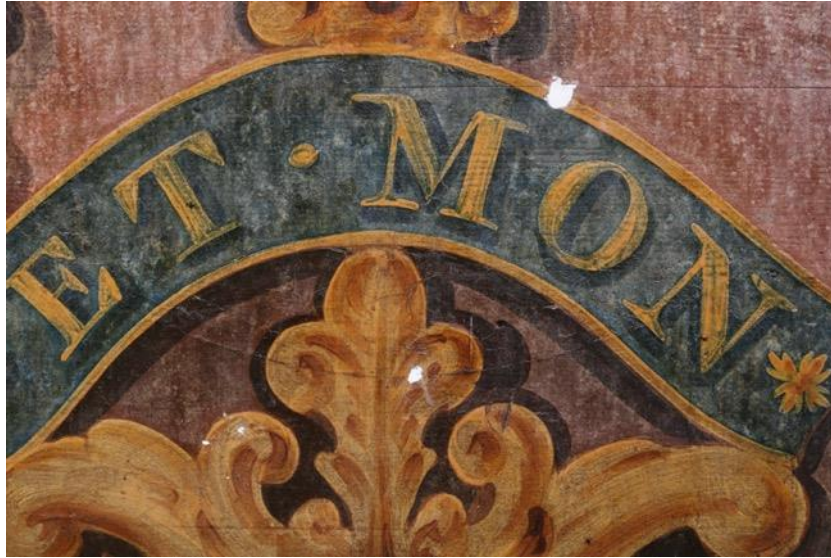
**Plate 12** Detail of fill in small losses before retouching

Following cleaning, a brush coat of conservation grade varnish was applied to saturate the paint layers, Paraloid B72 (15% in Shellsol A). Areas of loss and some uneven texture were filled with a putty made from chalk and 7% gelatine. Retouching was carried out with Gamblin retouching colours. Retouching sought to reduce the visual impact of the staining in the background by toning the most visually disturbing areas without retouching every single stain. Final spray coats of varnish were applied to even out the surface gloss Laropal A81 (15% in Shellsol A and white spirits). A layer of wax was applied to the frame to saturate the darks and protect it from dirt build up in the future.

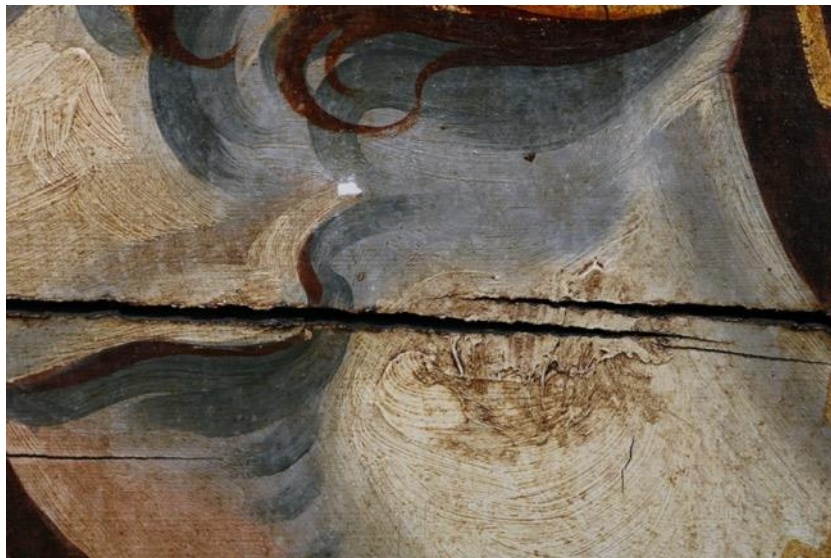
**Plate 13** Area of staining on the unicorn which could not be cleaned

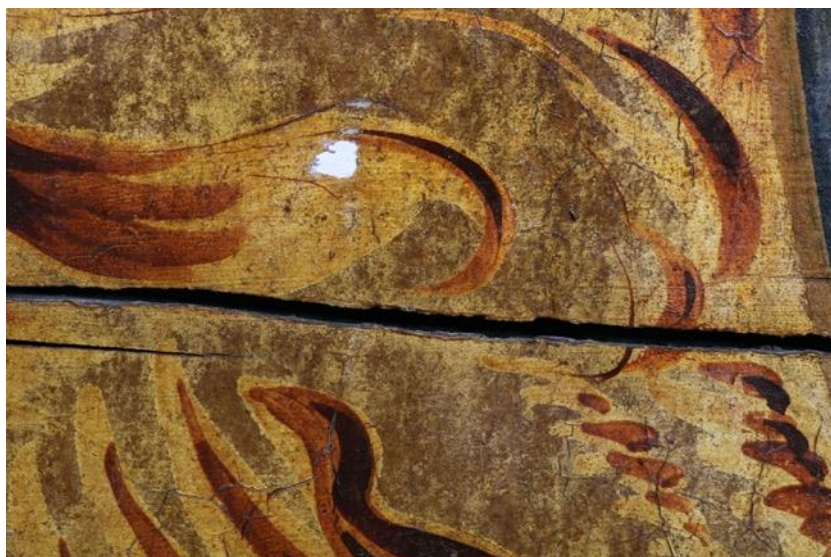
**Plate 14** Detail of fill in small losses before retouching

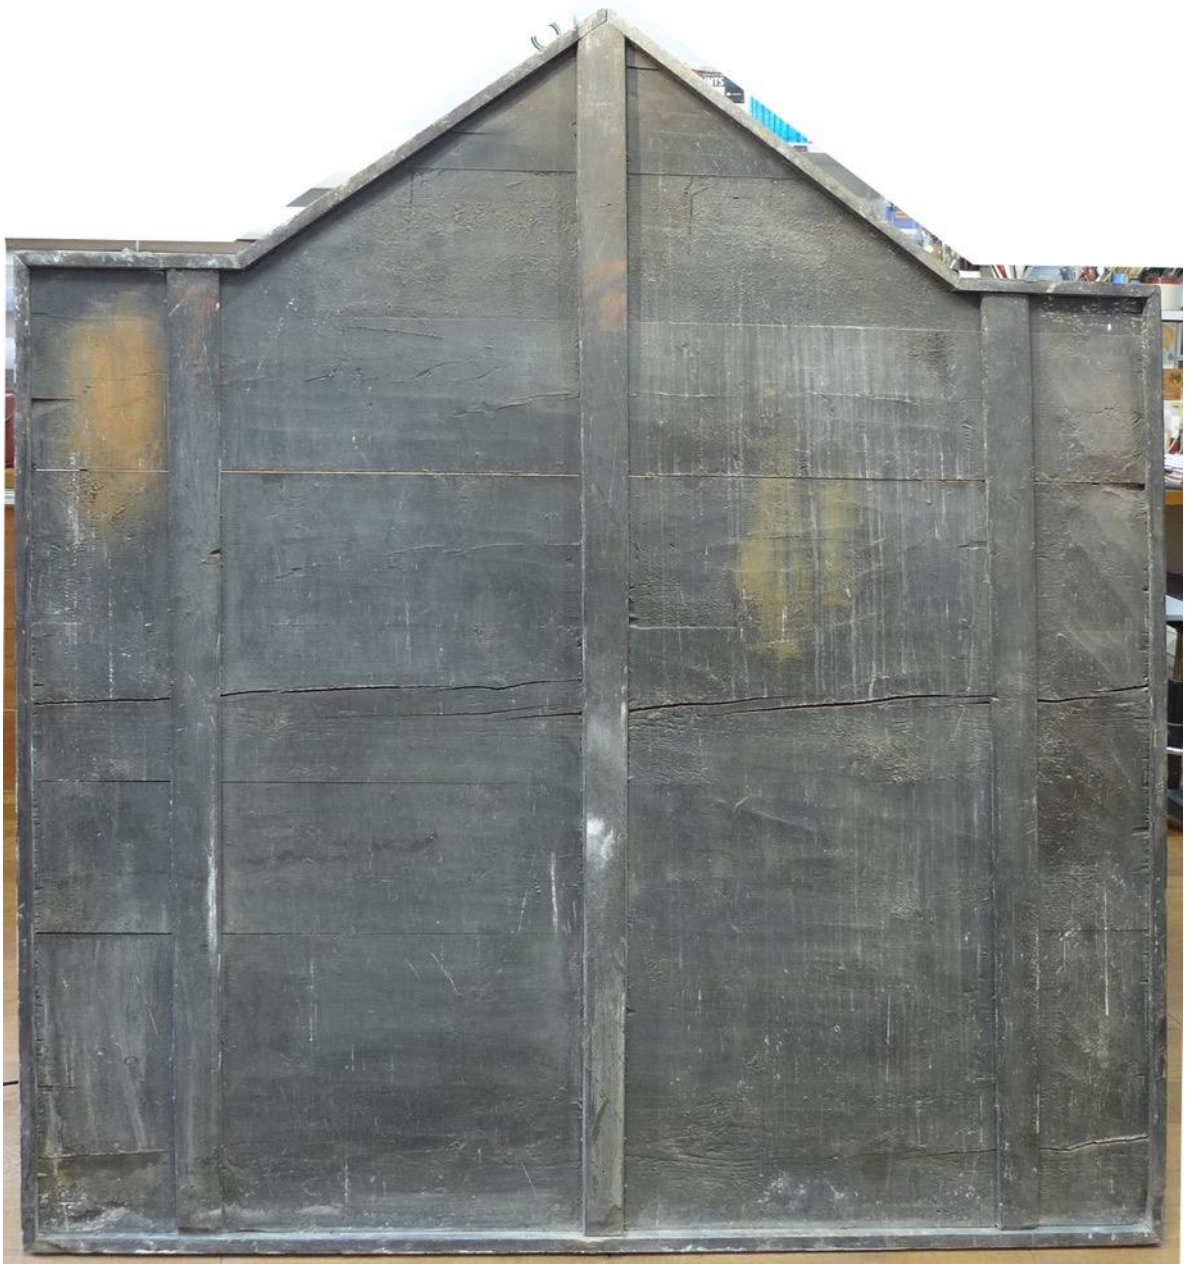
**Plate 15** Reverse after cleaning

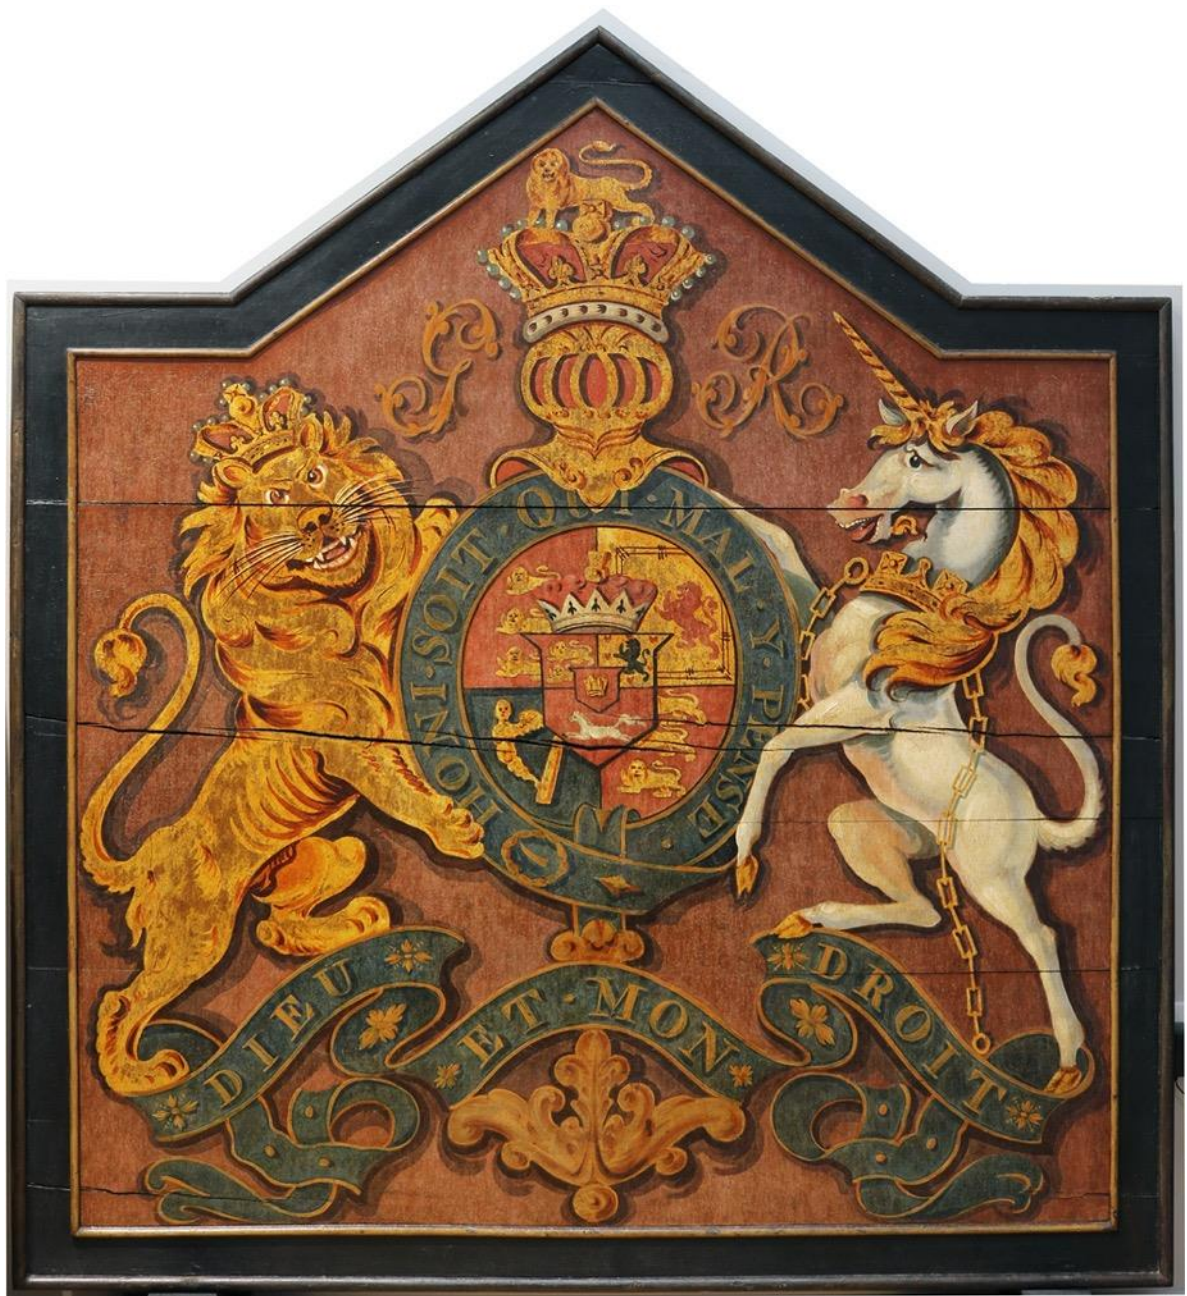
Plate 16      *Royal Coat of Arms, after treatment*

The treatment has addressed the aesthetic issues of the painting by removing old varnish layers and toning old staining to present the Royal Arms in a suitable manner. The panel was found to be in a very good, stable condition for its age. The painting was treated according to its condition and conservation requirements with the intention of ensuring the stability and improving the appearance without disguising the age of the painting or ignoring the fact that it has suffered some degree of deterioration in the past.
